Manhole Inspection Summary

Manhole # S45II_042MH

Insp Date: **2/18/10 12:22 PM**

Location Address: **Castle st**

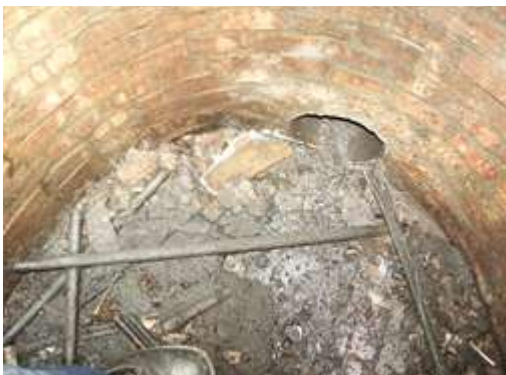
Defect 3

debris

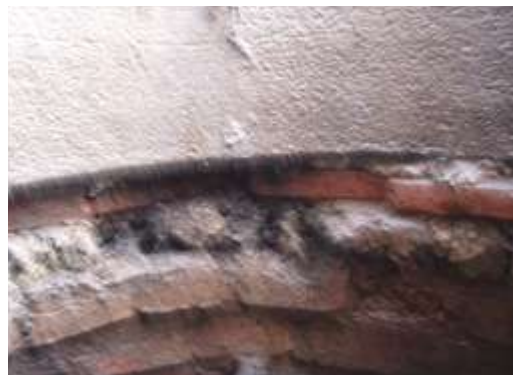
Defect 2

Condition: ☐ Sound ☐ Cracked ☐ Root Intrusion ☒ **Loose Brick** ☒ **Deteriorated**

loose bricks

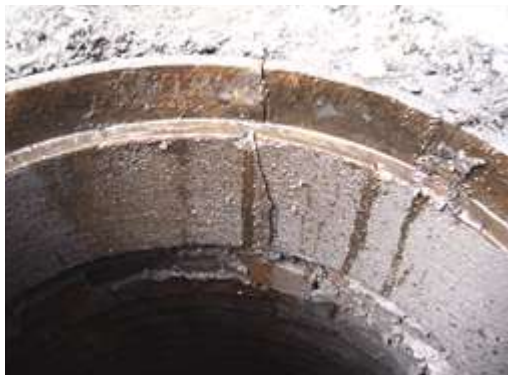
Defect 1

☒ **Cracked**

☒ **Leaks**

frame leaks

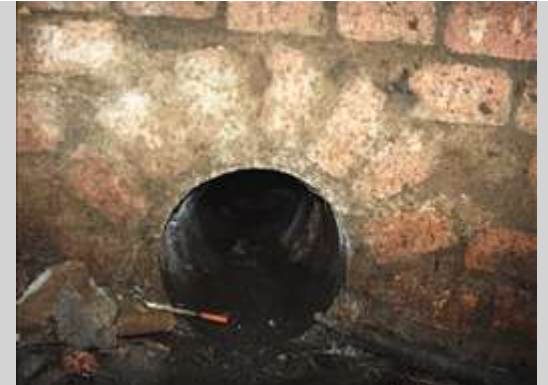
12 O'Clock Outflow

8 in. Circular Gravity Sewer
Pipe Out @ 12 O'Clock

Infiltration: **None** Pipe Seal Cond: **Sound**
